SKYQUAD ELECTRONICS & APPLIANCES PVT. LTD.  
Plant B

**Problem Statement:** The yield is dropped to < 90 % against the Target > 98.5%

- Project : IDU
- Model : JIDU6911
- Date : 12/02/2025 to Date 17/02/2025

Major contributors is flash programming information in IC U51 is invalid/ corrupted

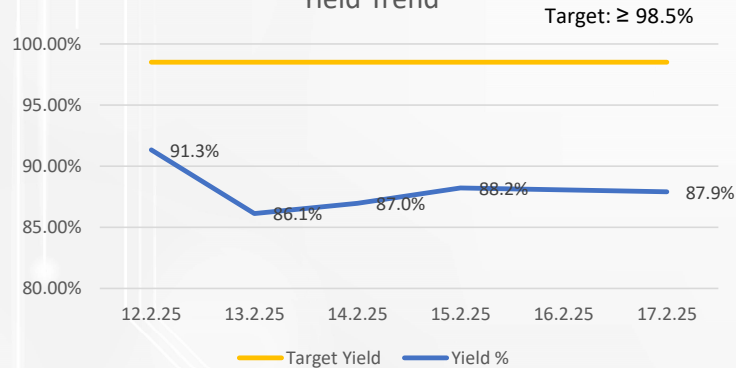
Yield Trend

| Date | 12.2.25 | 13.2.25 | 14.2.25 | 15.2.25 | 17.2.25 | Total |
|---|---|---|---|---|---|---|
| Yield % | 91.3% | 86.1% | 87.0% | 88.2% | 87.9% | 88.1% |

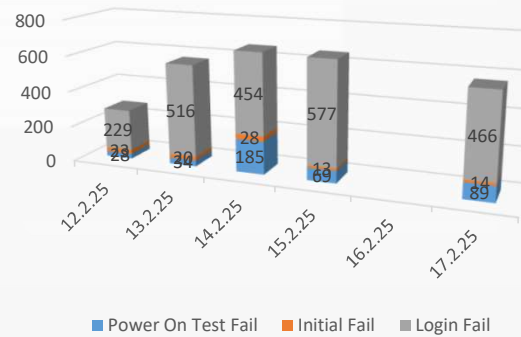
Defect Contribution

**Why-2.** In the defect % (i.e.11.9%), The major contributors are  
Power on fail (405#) , Initial fail (98#) and login fail (2242#)

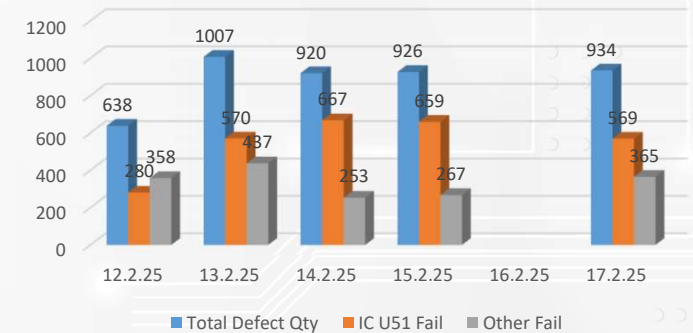
Total Defect Vs IC U51

| Component Location | 12.2.25 | 13.2.25 | 14.2.25 | 15.2.25 | 17.2.25 | Total |
|---|---|---|---|---|---|---|
| IC U51 Fail % | 43.89% | 56.60% | 72.50% | 71.17% | 60.92% | 62.03% |

**Why-4.** Due to IC U51 flash programming abnormality, the above defects occurred

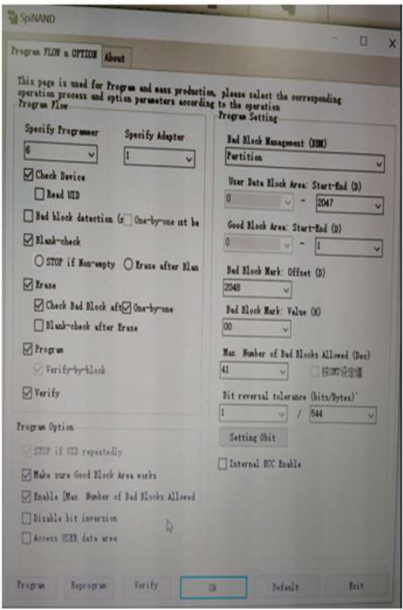
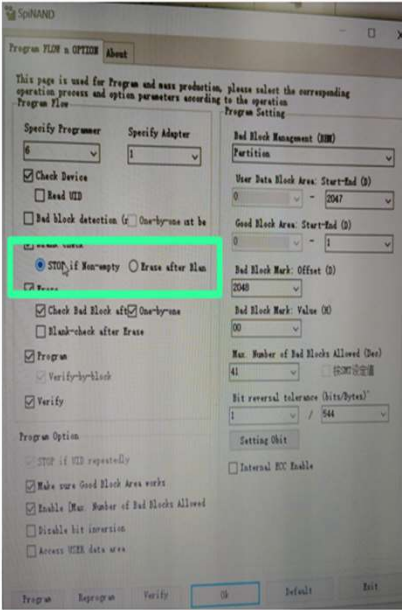
| Sr. No. | Before | After |
|---|---|---|
| 1 | | |

- **Corrective action:**
- The settings in Dediprog Programmer have sent to U848pro Programmer machine technical support team.
- Have found the Options for partition have not been verified during programming although checksum was reading as required.
- The settings has made aligned as per Dediprog programmer.
- Trail-1 have conducted for 300 # followed by additional trails (Trail-2 and Trail-3) to ensure yield consistency.

### The U848 pro programmer Setting :

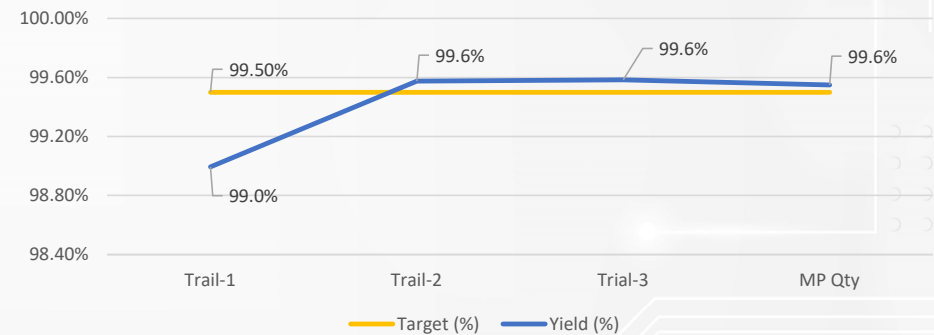
IC-U51 Defect Trend

- **Trail 1 report of 300 #: Date 04042025**
- Observation during trail-1- 298 #, ICU51 defect found – 03 #
- **Trail-2 conducted for 480 #: date 05042025**
- Observation during trail-1- 471 #, ICU51 defect found – 02 #
- **Trail-3 conducted for 1440 #: date 06042025**
- Observation during trail-1- 471 #, ICU51 defect found – 06 #
- The Overall Yield and its defect trend is as follows:

1. With respect to final yield at trail-3 (1440 #, 99.6%) , the programming with U848 Pro buy off given to mass production.
2. The major factor of failure i.e. Options in programming setting have incorporated in SOP.  
Document No: SEAL/E/AIP/227
3. Validation of flash programming must be done for >1000 Qty to validate the yield during the machine change/ program change before hand overing to mass production followed by PCN document.  
Doc Number: SEAL/E/PCN/124
4. Below are the milestones defined and its status – Closed.
